Manhole Inspection Summary

Manhole # S23C1_014MH

Location Address: **2460 Puget St** Cross Street: **Hollins Ferry RD**

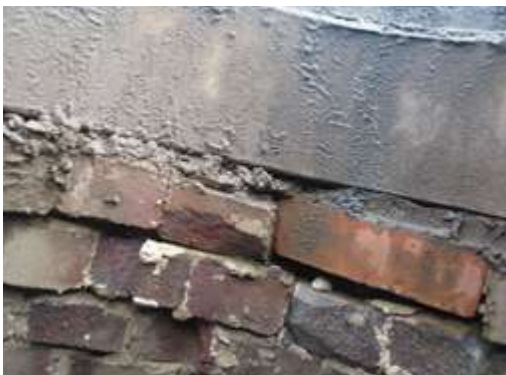
Defect 5

Chimney / Frame Adjustment ☒ Exists Material: **Brick** ☐ Parged Height: **6** (in.)
Condition: ☐ Sound ☐ Cracked ☐ Root Intrusion ☐ Loose Brick ☒ **Deteriorated**
Infiltration: ☐ None ☒ **Joint** ☐ Cracks ☒ **Mortar** ☐ Roots ☐ Wall

chimney deteriorated with flow at mortar

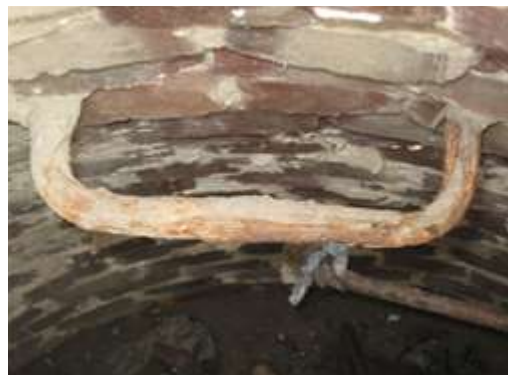
Defect 4

Steps Count: **2** Missing: **0** ☒ **Corroded**

corroded rung

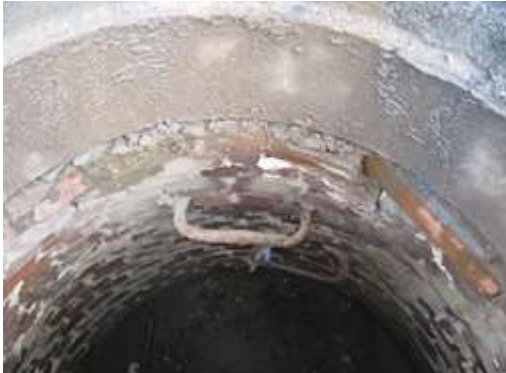
Defect 3

Frame Offset: **0** (in.) Condition: ☐ Sound ☐ Cracked ☒ **Leaks**

infiltration at lid & chimney joint

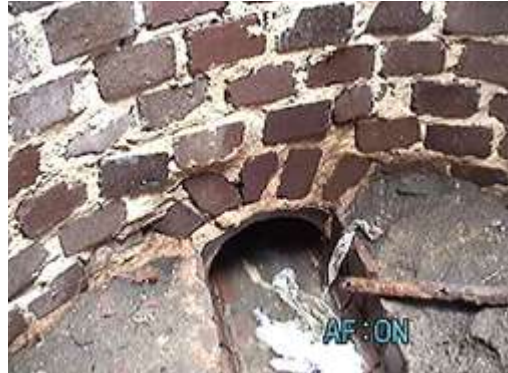
Defect 2

Bench ☒ Exists Material: **Brick** ☐ Parged
Condition: ☐ Sound ☐ Cracked ☐ Root Intrusion ☐ Deteriorated ☐ Leaks ☒ **Debris**

Channel Material: **Brick** ☐ Parged
Channel Exposure: **Fully Open** Junc Dist: **0** nearest .5 ft. Azimuth: **0**
Condition: ☐ Sound ☐ Cracked ☐ Root Intrusion ☐ Deteriorated ☐ Leaks ☒ **Debris**

debris in channel and bench

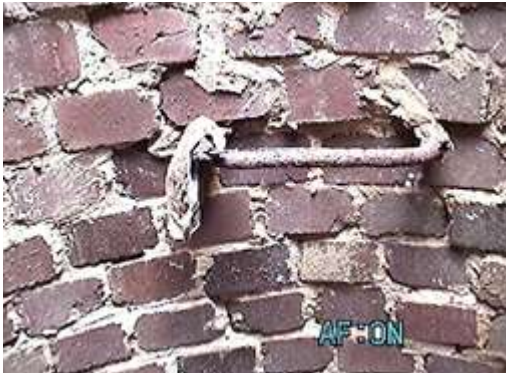
Defect 1

Surcharge ☒ **Evidence Of Surcharge** Depth: **1** (ft.) ☐ Active Surcharge Present

evidence of surcharge 1"

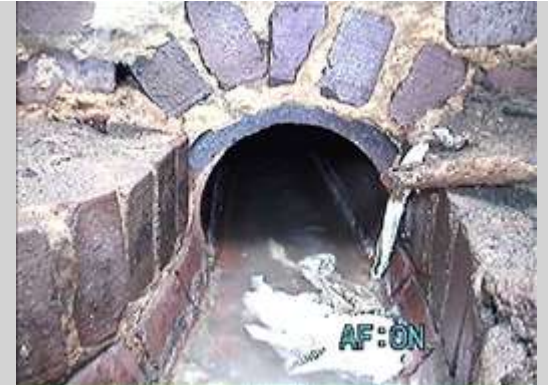
12 O'Clock Outflow

Pipe Height: **8.4** (in.) Rod and Bar (Angled)
Pipe Material: **Clay** ☐ Pipe Lined
Invert Depth: **6.15** (ft.) Flow Characteristics: **Slow**
Deposits: ☒ None ☐ Mud ☐ Sludge ☐ Debris ☐ Grease
Silt Depth: **0** (in.) Deposits Extent:
Infiltration: **None** Pipe Seal Cond: **Sound**

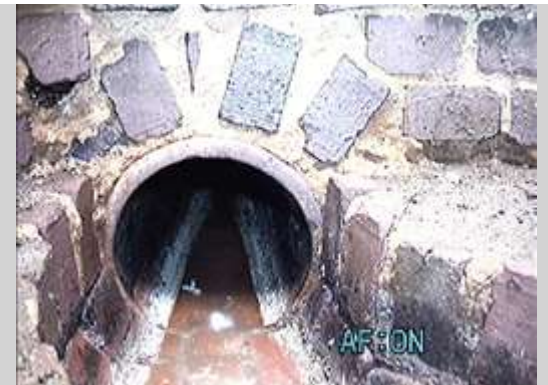
9 O'Clock Inflow

Pipe Height: **8.4** (in.) Rod and Bar (Angled)
Pipe Material: **Clay** ☐ Pipe Lined
Invert Depth: **6.01** (ft.) Flow Characteristics: **Slow**
Deposits: ☒ None ☐ Mud ☐ Sludge ☐ Debris ☐ Grease
Silt Depth: **0** (in.) Deposits Extent:
Infiltration: **None** Pipe Seal Cond: **Cracked**
